Article

Assessing the Impact of a Risk-Based Intervention on Piped Water Quality in Rural Communities: The Case of Mid-Western Nepal

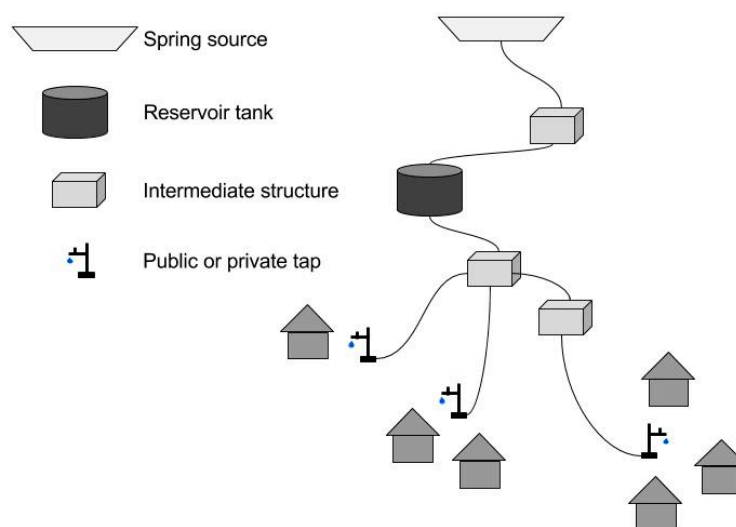
Figure 2. Sketch of a typical gravity-fed piped water scheme (or sub-scheme). Each scheme is composed of 1–4 sub-schemes. Sub-schemes comprise one water project for the same community but make use of independent water sources. Within a sub-scheme, one water source can feed several reservoir tanks that distribute water to different areas of the village. The intermediate structures can be distribution and collection chambers, purge valve chambers, break pressure tanks or interruption chambers, and air valve chambers.

The selected water schemes were constructed between 2012 and 2016; all were completed at least one year prior to this research. All are simple gravity-fed piped networks with spring sources, except one that includes a solar-powered lifting pump to deliver water from a downhill reservoir to the uphill distribution tanks. All the schemes provide intermittent water services with variable opening times and service durations throughout the year, as is common in the hilly region. They are all similar in their layout with a spring source that is connected to a reservoir tank by a distribution line, with water then flowing to the taps (Figure 2). All the selected schemes deliver water to public taps except one that has private taps only.

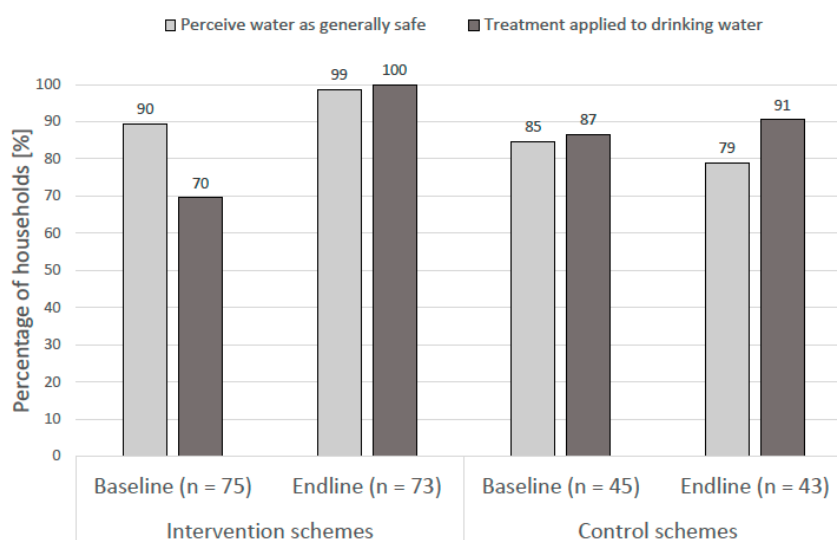
Figure 3. Drinking water safety perception and treatment coverage among the households served by the intervention and the control schemes from the baseline to the endline period.

Regarding water treatment practices, at the baseline visit, fewer households in the intervention schemes reported treating their drinking water (70%) compared with the households in the control schemes (85%). The share of the households adopting the treatment practices increased among all households from the baseline to endline visits (Figure 3). However, the observed difference in the treatment coverage was only statistically significant among the intervention schemes ($\chi^2(1, n = 147) = 26.18, p = 0.00$), with all the households reporting that they practiced some form of household water treatment by the endline.

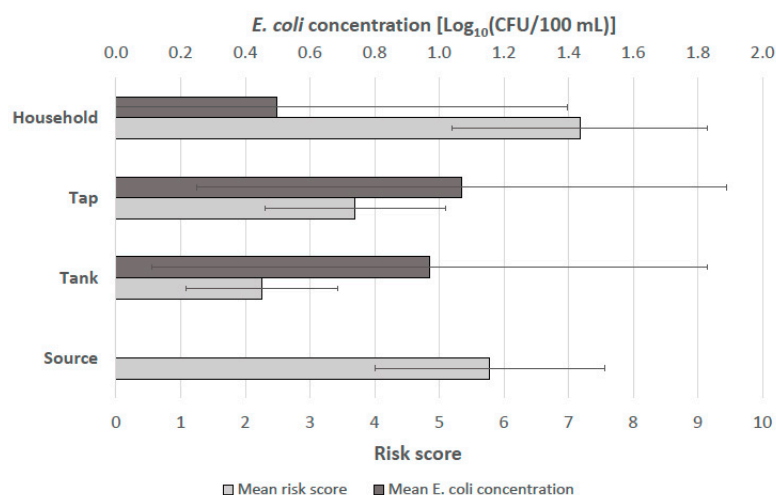
Figure 4. Mean risk scores from monthly sanitary inspections and mean *Escherichia coli* concentrations from monthly sampling ($n = 23$, standard deviation bars shown). The maximum risk score is 10.

Regular monitoring of the intervention schemes included water quality testing and structured sanitary inspections that provided a calculated risk score. Figure 4 shows the mean risk scores and mean *E. coli* concentrations at the source, reservoir tank, tap, and household. The microbial water quality was not measured at the sources because no samples could be collected without damaging the integrity of their protective structures.

The average risk score was higher at the sources (due to poor protective measures) and the households (due to recontamination vulnerabilities) than at the taps and reservoir tanks. However, the microbial water quality of household stored water was on average better than at the taps and reservoir tanks. With these results, the sanitary inspections did not accurately predict the water quality test results at each given point. The household water treatment practices appeared to improve the stored water quality, even if the overall sanitary state of the household was poor according to the inspection forms. Rain events during the monitoring day and the preceding day were recorded in the sanitary inspection forms and examined as a potential factor explaining variations in the microbial water quality. However, the results did not reveal any meaningful impact of rain on the observed microbial concentrations.

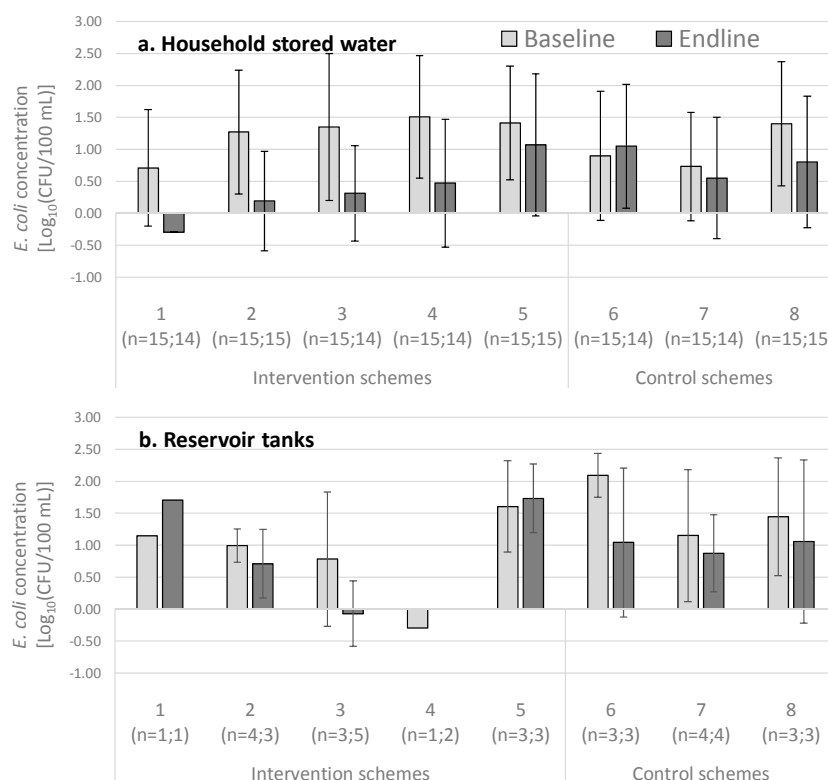
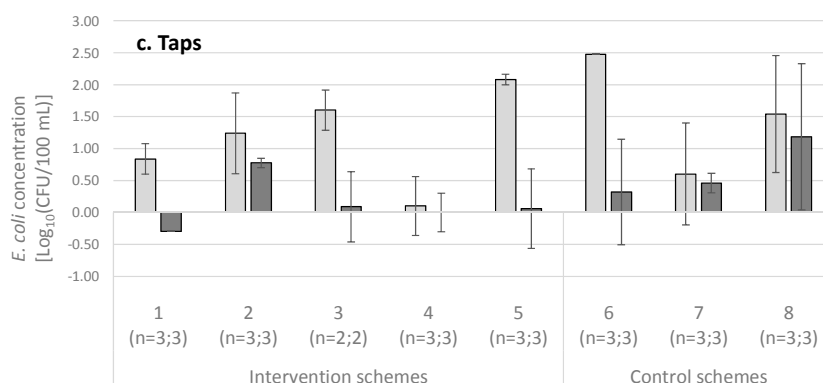
Figure 5. Cont.

Figure 5. Mean *E. coli* concentrations of the (a) household stored water containers, (b) reservoir tanks, and (c) taps at the baseline and endline for each of the eight schemes. The standard deviation bars are shown.

The mean *E. coli* contamination of household stored water is shown in Figure 5a. These results showed that the contamination during the baseline was on average greater in the intervention schemes than in the control schemes. By the endline visit, the opposite situation was observed, with most intervention schemes having lower contamination levels within the stored water on average, as compared with the control schemes. At most reservoir tanks and taps at the intervention and control schemes, the water quality at the baseline had improved by the endline visit (Figure 5b,c). A particularly high level of fecal contamination was observed in the reservoir tanks and taps of the control scheme number six during the baseline visit.

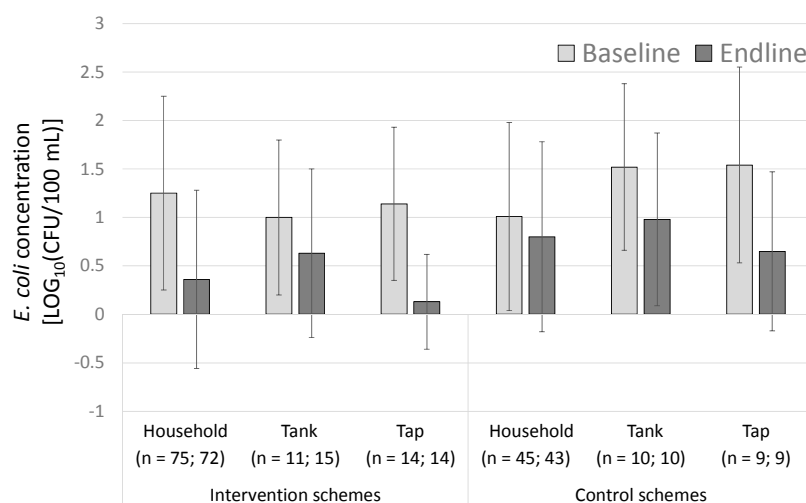
Figure 6. Mean *E. coli* contamination at each sampling point at the baseline and endline measurements for the intervention and control schemes. The standard deviation bars are shown.

Figure 6 shows the mean *E. coli* concentrations for the intervention and control schemes at each sampling location. The greatest reductions in the contamination between the baseline and endline measurements are seen at the households and taps among the interventions schemes (see the Supplementary Materials for additional microbial analyses across the sampling points (Section S7); within the chlorinated schemes specifically (Section S8); among the households using and not using ceramic water filters (Section S9); and other detailed microbial results (Section S10)).
